In the
Supreme Court of the United States

STATE OF FLORIDA,

STATE OF GEORGIA,

**PRE-FILED DIRECT TESTIMONY OF FLORIDA WITNESS
G. MATHIAS KONDOLF, PH.D**

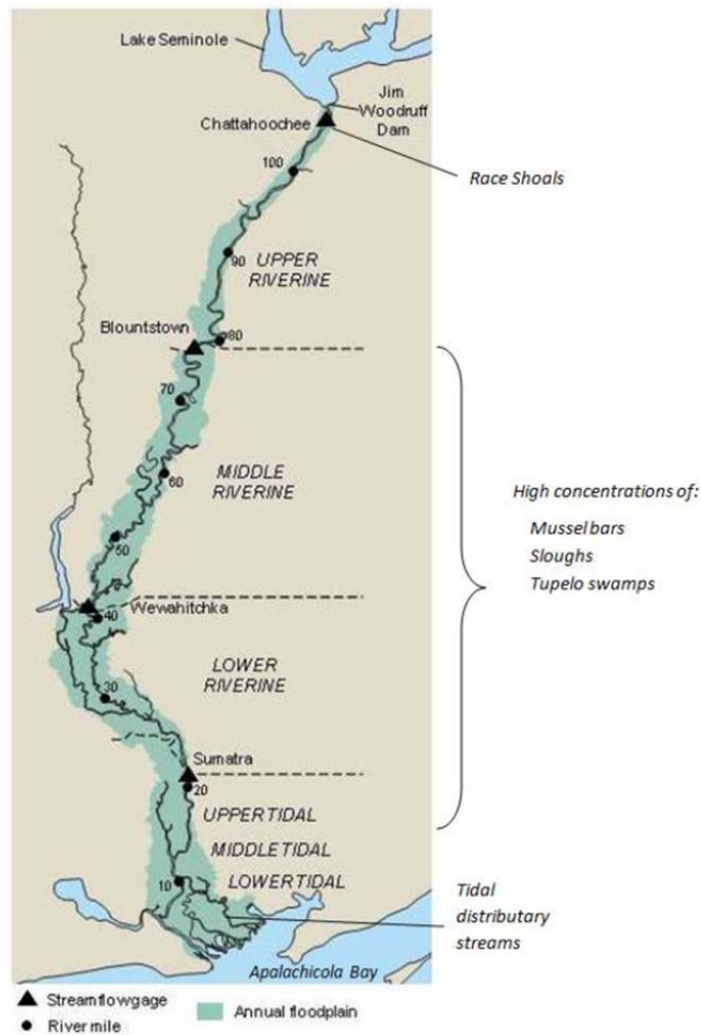
Fig. 1 – Major reaches of Apalachicola River and location of biological habitats harmed by upstream depletions. This is a true and accurate copy of Figure 1 from the Expert Report of Dr.

is formed by the confluence of the Flint and Chattahoochee Rivers, immediately north of the Florida-Georgia border at the Lake Seminole Reservoir formed by Jim Woodruff Dam. The River then flows 106 miles from the Jim Woodruff Dam to its mouth in the Apalachicola Bay. There are four distinct reaches of the river: an upper reach extending from RM 106 to RM 80; a middle reach extending from RM 80 to RM 42; a lower non-tidal reach extending from RM 42 to RM 20; and the tidal reach extending the lowermost 20 miles to the river's mouth at Apalachicola Bay. Figure 1, below, illustrates the Apalachicola and its reaches.

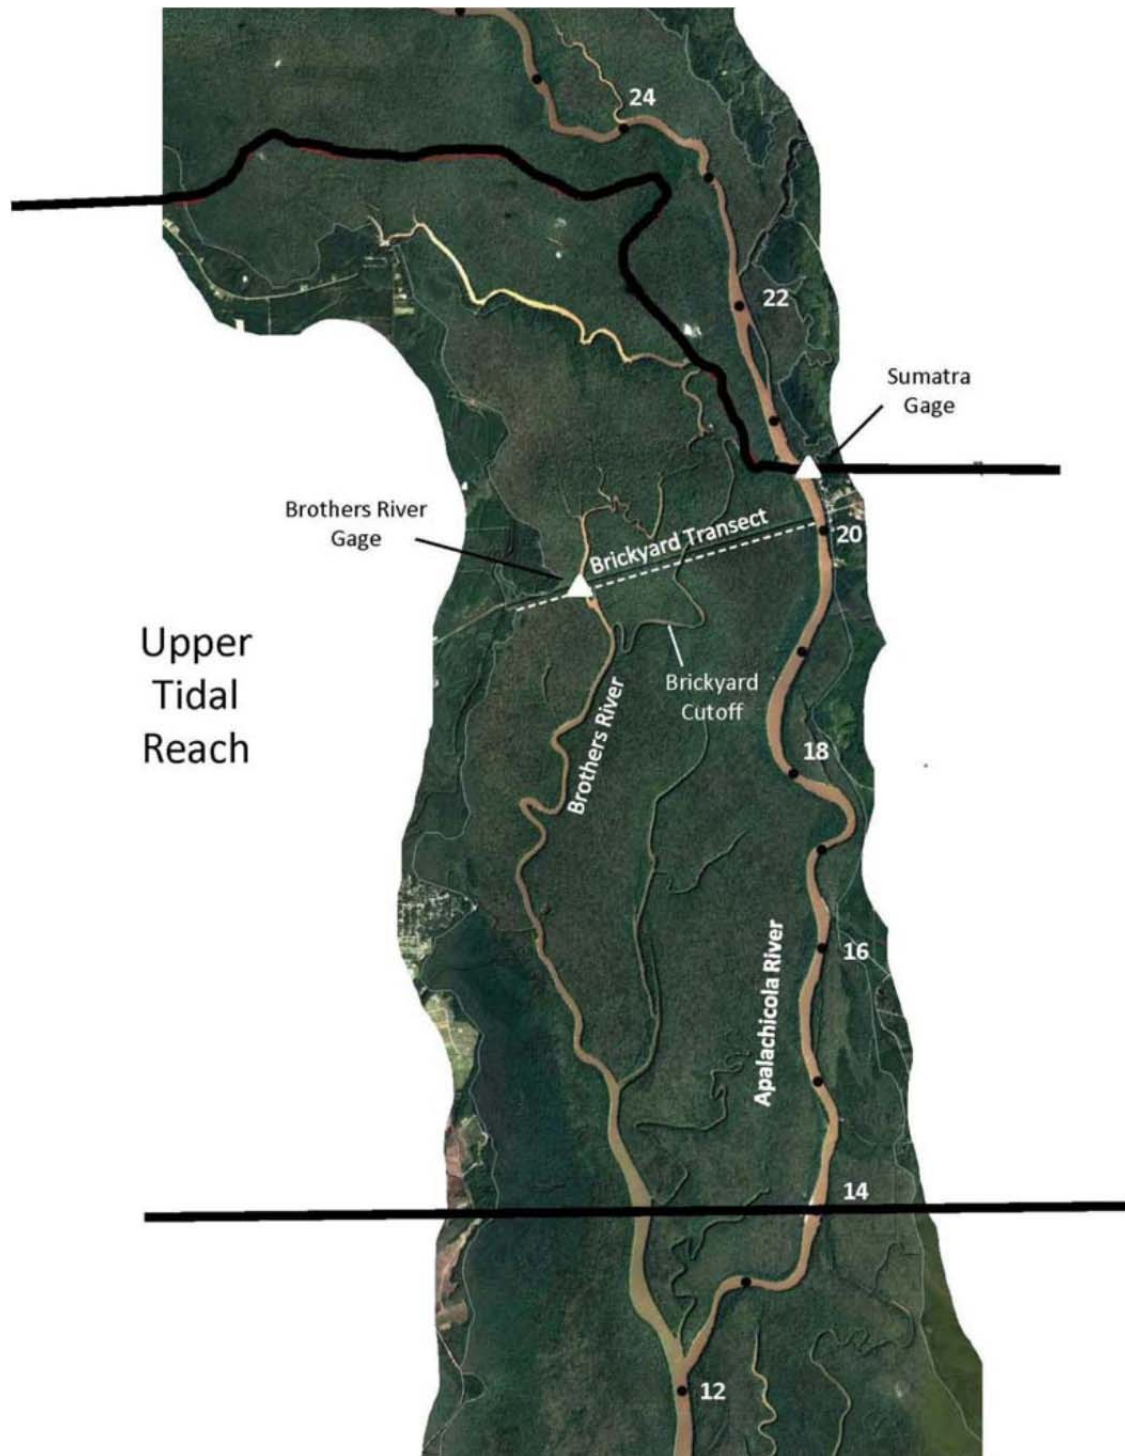
Fig. 2. Aerial photo of upper tidal reach showing reach boundaries, gaging station locations, and streams crossing the Brickyard Transect. Numbers are river miles. This figure was created under my supervision, using generally accepted scientific principles and methodology, based on an aerial photo accessed from Google Earth, dated May 27, 2005. It is the kind of photo regularly relied upon by experts in my field, and I reviewed and relied on this photo to form my opinions in my Expert Report and in this testimony.

34. There are long reaches of the River where the geomorphology was not impacted by Army Corps navigational improvements. The most prominent reach of unaffected river extends from Apalachicola Bay through the entire tidal reach and continues three miles into the lower riverine reach. Figure 2 is a true and accurate copy of Figure 4 of my expert report, an map showing the upper tidal and lower riverine reaches.

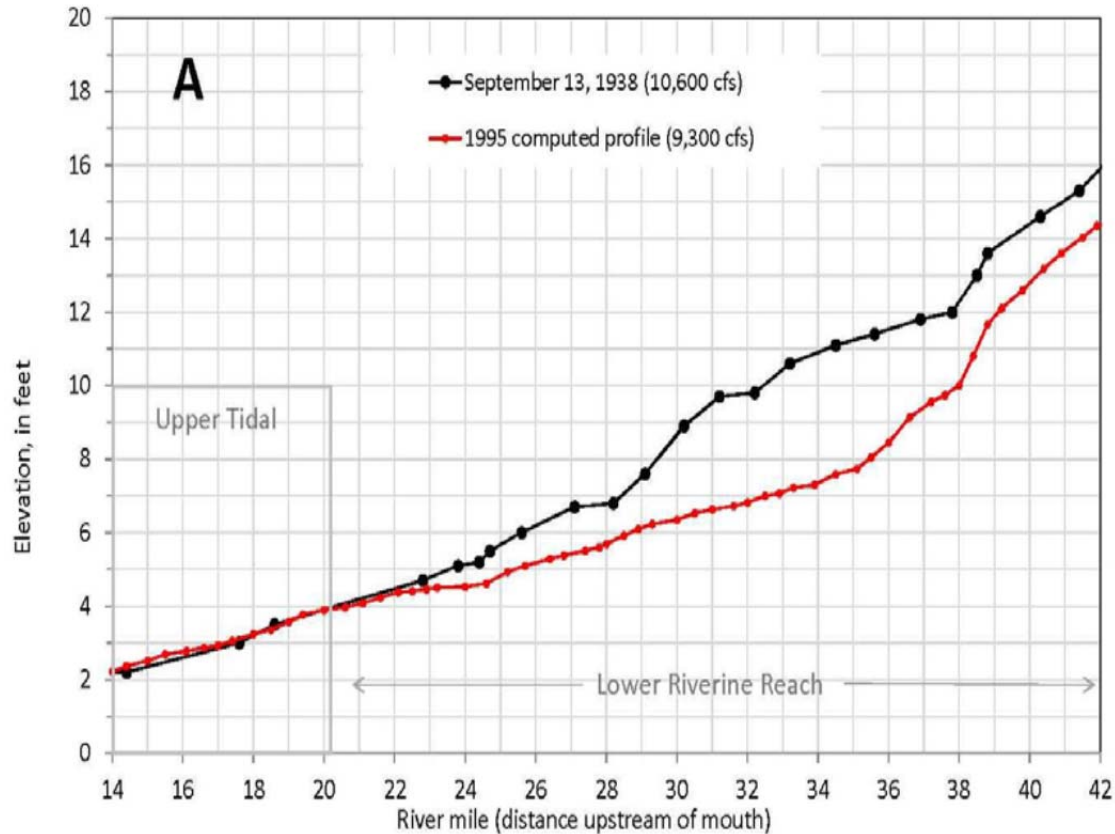
Fig. 3 – Water-surface profiles measured by the Corps in the upper tidal and lower riverine reaches. When flow at the Chattahoochee gage was about 10,000 CFS the 1995 water-surface profile directly superimposes on top of the 1938 water-surface profile from River Mile 23 to the bay. I generated this chart using generally accepted scientific methodology. It accurately represents the source data. The same chart is presented in my Expert Report. This data is the kind of data regularly relied upon by experts in my field, and I reviewed and relied on this data to form my opinions in my Expert Report and in this testimony.

35. In my expert report, I created an important figure, which compares the post-dredging (1995) water surface profile of the river with the pre-dredging water surface profile, from RM 42 downstream to RM 14, with both corresponding to flows of approximately 10,000 cfs. Kondolf Expert Report, FX-796, at 12, Figure 5A. Figure 3 below is a true and accurate copy of Figure 5A from my expert report, which demonstrates there was no change in the water levels of the River beginning at RM 23 and continuing south. A water surface profile is simply the elevation of the surface of the River given a particular flow level plotted against river mile (distance upstream from Apalachicola Bay). The superimposed profiles show that upstream of RM 23 the channel had changed such that the water surface profile was lower after the period of intensive dredging. Thus, for the River upstream of RM 23, I conclude that the change in water surface elevation is due to the changes in channel geomorphology.

36. The greatest geomorphic change (and thus difference in water surface profile) between the 1938 profile (pre-dredging) and the 1995 profile (post-dredging) is in RM 30-38. However, the difference between the profiles declines downstream and disappears by about RM 23. There was some historical dredging in this reach, but much less occurred than areas further upstream. Therefore, I conclude that the geomorphic changes did not affect river elevation and its ability to connect to the floodplain south of RM 23. Accordingly, the lowest three miles of

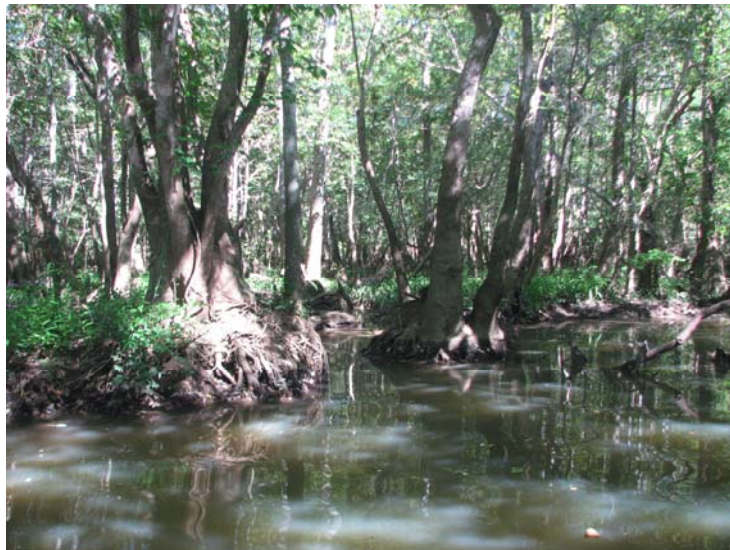
Fig. 4 – Illustration of tupelo swamp forest in the upper tidal reach near Brothers River. I understand this photo was taken by the Florida Fish and Wildlife Conservation Commission on September 15, 2016.

37. The upper tidal reach in particular hosts unique, significant habitats, including a large swathe of tupelo swamp forests, which are vulnerable to water level decline. Kondolf Expert Report, FX-796, at 13. The reach also provides important access to inundated forests for fish. As flows increase or decrease in the River, water levels in the river and the floodplain and sloughs in this reach directly respond. The tupelo swamp forest in the upper tidal reach is illustrated in Figure 4.

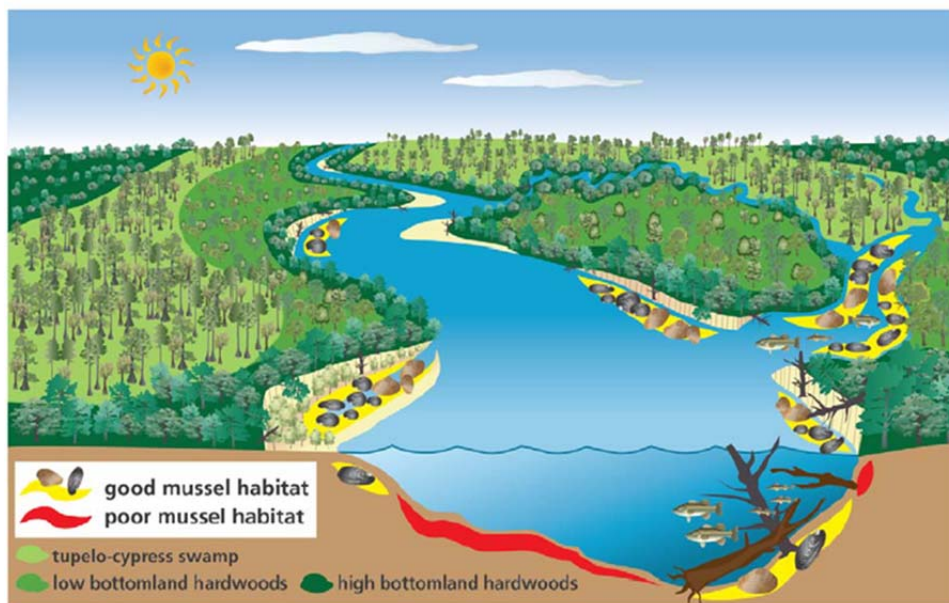
Fig. 5 – A three-dimensional conceptualization of the Apalachicola River, highlighting areas of the river that provide preferred mussel habitat and showing the location of tupelo-cypress swamps in relation to the river. This is a true and accurate copy of Figure 4 from the Expert Report of Dr. David Allan, FX-790. It is the kind of figure and report regularly relied upon by experts in my field, and I reviewed and relied on the Expert Report of Dr. Allan and this figure in preparing my own Expert Report and this testimony.

42. The River’s channel margins have stabilized since the cessation of dredging 16 years ago. This has permitted the recovery of geomorphic features that provide suitable habitat for mussels and other organisms. Allan Expert Report, FX-790, at 19, Figure 4. Mussels require a stable substrate, however, during the period of active dredging and spoil disposal, sandy sediments along the channel margin were continually disturbed. The mussels could not establish

themselves in this environment of shifting sands, and they were vulnerable to flood scour and to being smothered by spoil disposal or disturbed sands drifting downstream. The end of dredging has allowed habitats for these endangered mussels to stabilize, promoting the recovery of the species.

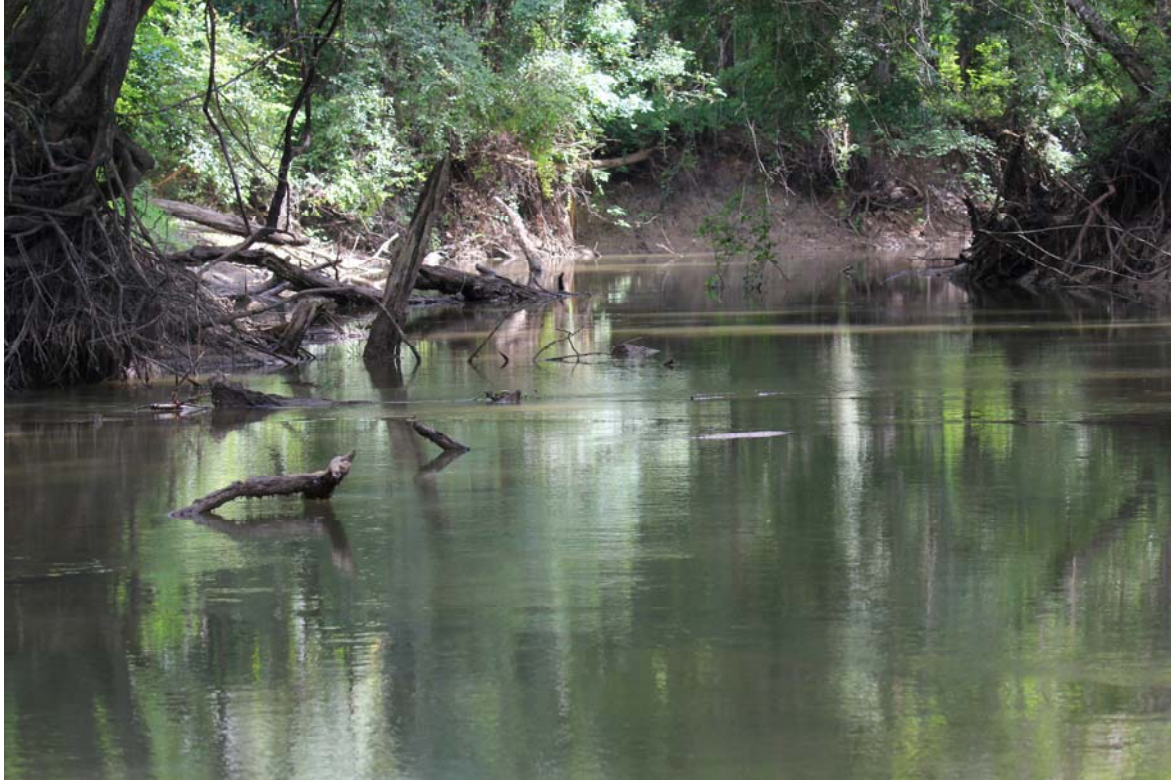
Fig. 6 – Swift Slough. Figure 7 is a true and accurate copy of FX--818g, which I understand was a photograph taken by personnel from the Florida Fish and Wildlife Conservation Commission on August 2, 2016, depicting Swift Slough.

48. Swift Slough is located in an area of the River that experienced significant historical dredging. As noted above, sand put into circulation by the disturbance caused by dredging deposited in Swift Slough, raising its bed elevation and thus increasing the flow needed to connect it to the main river. Even with the partial recovery of the slough in recent years, in many dry months when river elevations are low, the slough is still cut off from river inflow, with serious ecological impacts. As documented in Dr. Allan's expert report, the harm to the mussel populations that make Swift Slough home has increased as upstream depletions have increasingly reduced flows in the Apalachicola. Dr. Allan's report demonstrates that increased flows would significantly reduce the harm to the mussel habitat provided by Swift Slough. The
