In the  
Supreme Court of the United States

**UPDATED PRE-FILED DIRECT TESTIMONY OF FLORIDA WITNESS  
THEODORE SCOTT HOEHN**

## **I. OVERVIEW OF THE APALACHICOLA RIVER & FLOODPLAIN**

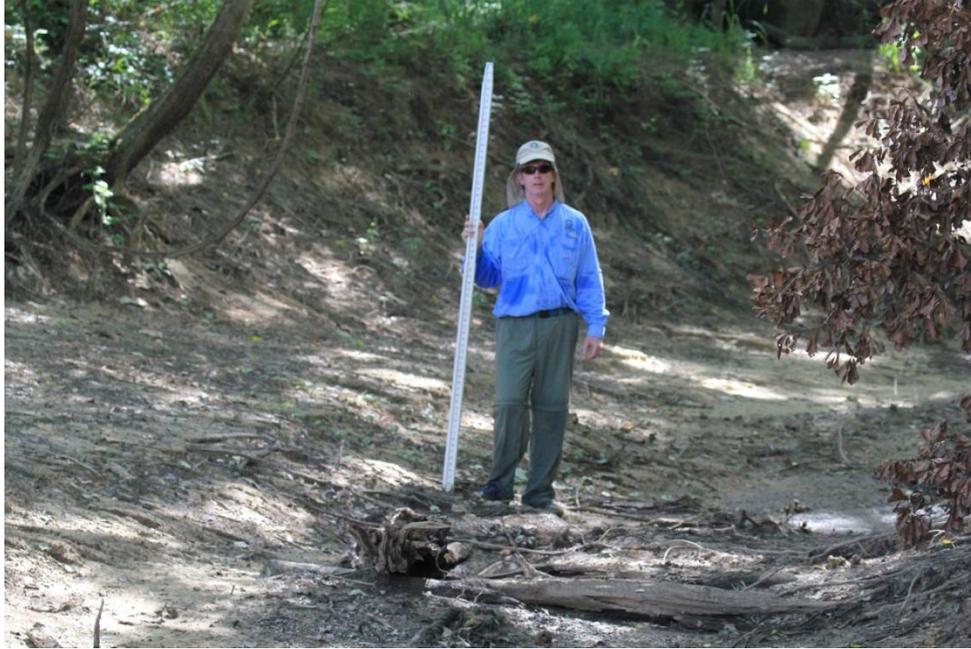
*Hog Slough in the Lower Reach, near River Mile 40. This is a true and correct copy of a photo of me taken on August 2, 2016, and accurately represents conditions at Hog Slough on that day when river flow was approximately 6,500 cfs as measured at the Chattahoochee gage on the Apalachicola River. (FX-812o).*

44. As I have testified, without a continuous connection to fresh River flows, the sloughs, the lifeblood of the floodplain, turn into puddles and ponds, sometimes drying up altogether in the dryer late summer months when flows are the lowest. When the River drops below the level of the slough's mouth, water stops flowing into the slough, and it becomes "disconnected" from the River. When this happens, the water in the slough becomes stagnant and dissolved oxygen in the water drops to levels that are lethal for many fish and mussels within a matter of days. Prolonged disconnection dries sloughs entirely, killing all aquatic animals trapped in the slough when the River declined. Below are some of the examples of sloughs photographed in August 2016 during a low water period.

46. However, as is demonstrated through the photos taken of me in August of this year (2016), sloughs present another set of risks for mussels that result directly from inadequate flow levels. Stagnant sloughs typically warm more quickly than sloughs with flowing water. Elevated temperatures are highly stressful and potentially lethal for mussels.

- FX-812o: Photograph of Hog Slough taken on August 2, 2016. This is a true and accurate copy of a photograph of the slough taken on August 2, 2016, during a river trip which I attended as part of my duties with the FWC. I was present when the photograph was taken, and it accurately represents conditions at the slough on that day.

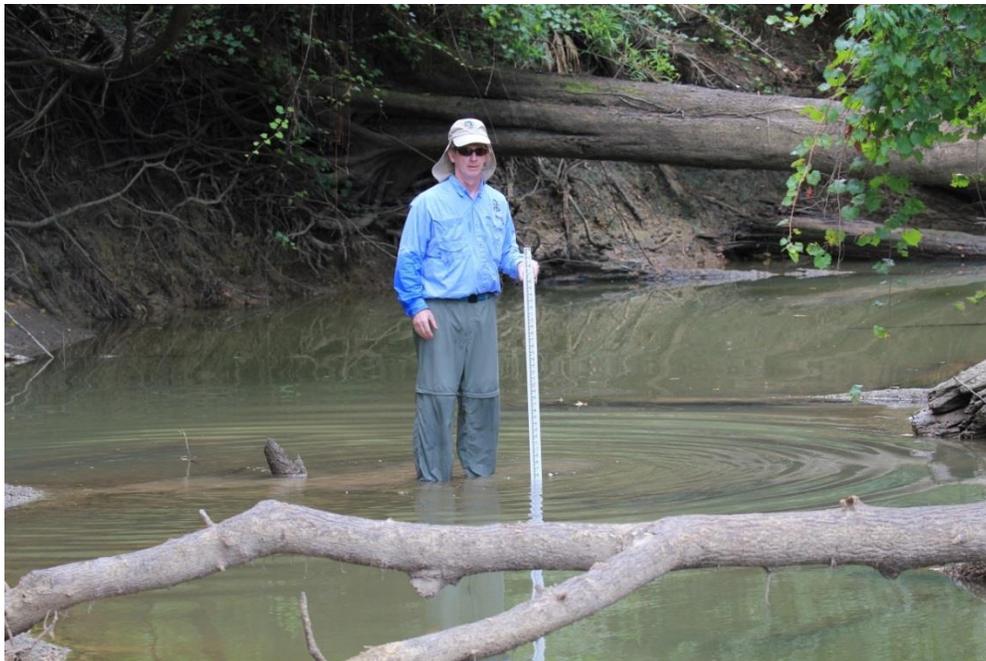
*Small Slough in the Lower Reach, near River Mile 40. This is a true and correct copy of a photo of me taken on August 2, 2016, and accurately represents conditions at an unnamed small slough on that day when river flow was approximately 6,500 cfs as measured at the Chattahoochee gage on the Apalachicola River. (FX-817h).*

- FX-817h: Photograph of Small Slough taken on August 2, 2016. This is a true and accurate copy of a photograph of the slough taken on August 2, 2016, during a river trip which I attended as part of my duties with the FWC. I was present when the photograph was taken, and it accurately represents conditions at the slough on that day.

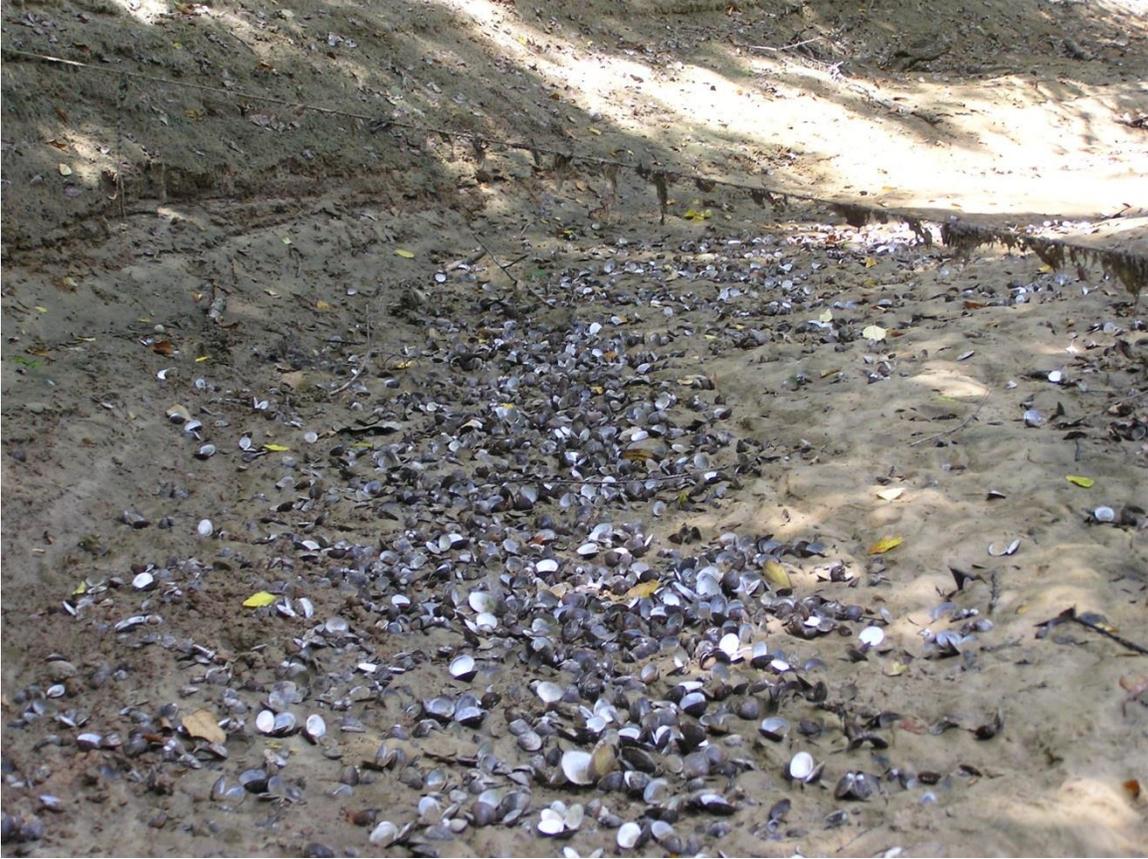
*Dead mussels stranded in Swift Slough, July 3, 2006. This is a true and correct copy of a photo taken by me, and accurately represents conditions at Swift Slough on July 3, 2006.*

48. Sadly, I have personally witnessed disconnected sloughs with increasing frequency in recent years. I have seen large numbers of dead mussels in relatively large sloughs such as the River Styx; I have also seen it happen in sloughs that require relatively higher flows near 10,000 cfs, such as Mary Slough; and I have even seen it happen in sloughs that remain connected to the river at low flows, such as Swift Slough (connected at approximately 5,700 cfs).

- Photograph of Dead Mussels at Swift Slough taken on July 3, 2006. This is a true and accurate copy of a photograph of mussels in Swift Slough taken on July 3, 2006. I took this photograph as part of my duties with the FWC. The photograph accurately represents conditions at the slough on that day.

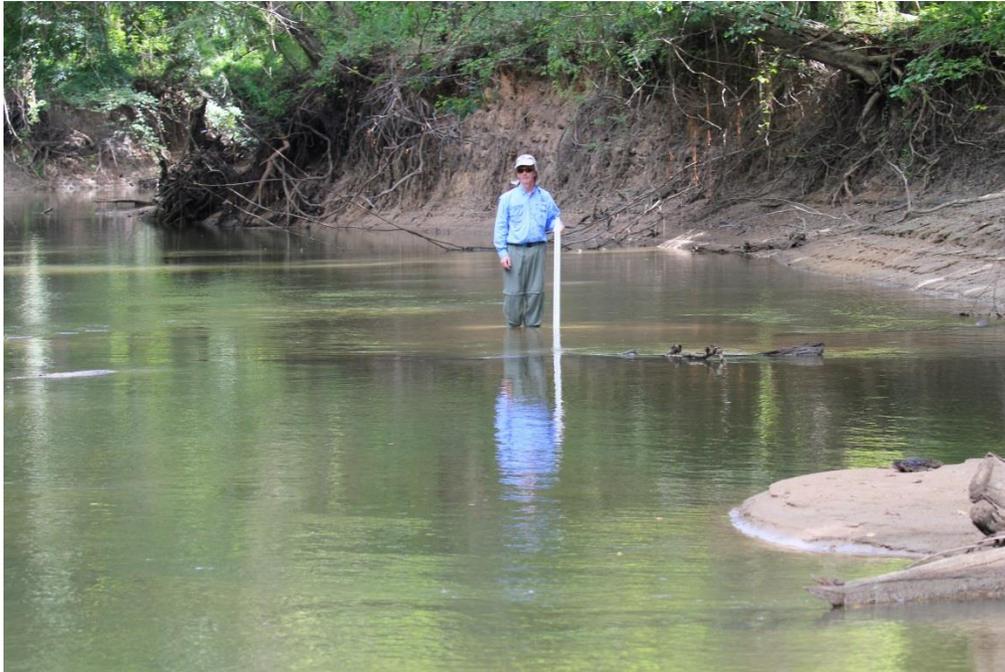
*Swift Slough in the Lower Reach, near River Mile 40.2. This is a true and correct copy of a photo of me taken on August 2, 2016, and accurately represents conditions at Swift Slough on that day when river flow was approximately 6,500 cfs as measured at the Chattahoochee gage on the Apalachicola River. (FX-818h).*

- FX-818h: Photograph of Swift Slough taken on August 2, 2016. This is a true and accurate copy of a photograph of the slough taken on August 2, 2016, during a river trip which I attended as part of my duties with the FWC. I was present when the photograph was taken, and it accurately represents conditions at the slough on that day.

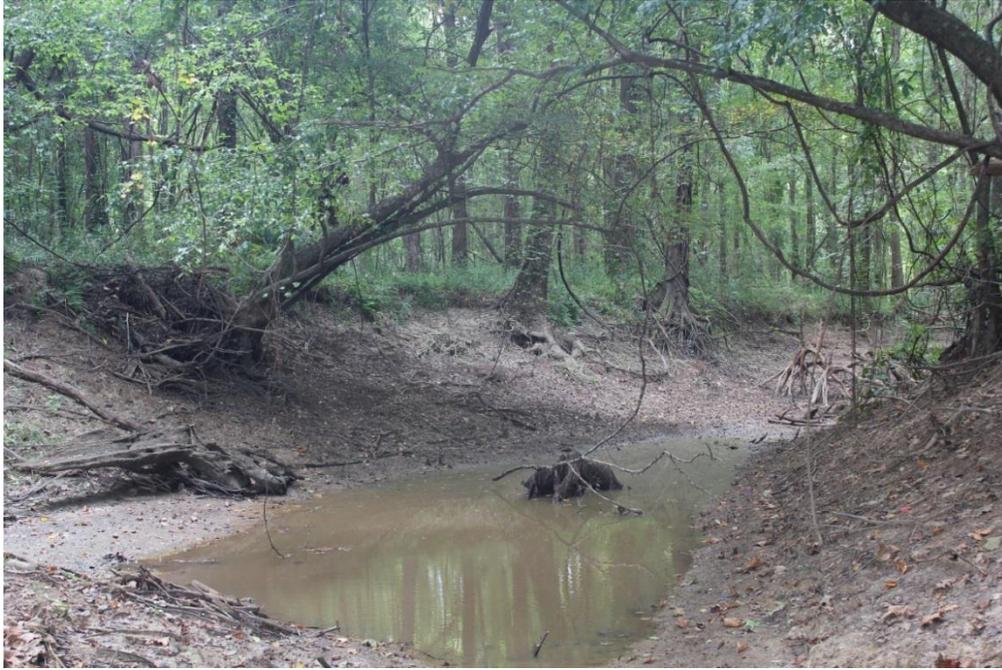
*An unnamed slough in the Lower Reach, near River Mile 49.8. This is a true and correct copy of a photo taken on August 31, 2016, during a river trip I attended. I was present when the photo was taken, and it accurately represents conditions on that day when the slough was completely disconnected and river flow was approximately 5,500 cfs as measured at the Chattahoochee gage on the Apalachicola River. (FX-824q).*

- FX-824q: Photograph of Unnamed Slough after Dog Slough taken on August 31, 2016. This is a true and accurate copy of a photograph of the slough taken on August 31, 2016, during a river trip which I attended as part of my duties with the FWC. I was present when the photograph was taken, and it accurately represents conditions at the slough on that day.

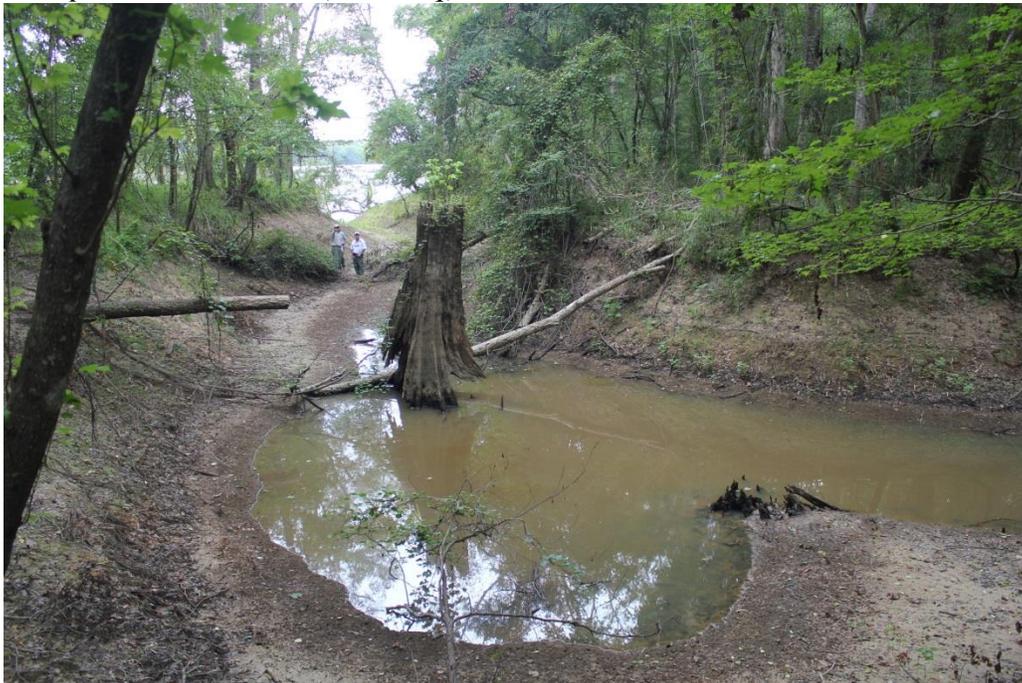
*Dog Slough in the Lower Reach, near River Mile 50. This is a true and correct copy of a photo of me taken on August 31, 2016, and it accurately represents conditions on that day when the slough was completely disconnected and river flow was approximately 5,500 cfs as measured at the Chattahoochee gage on the Apalachicola River. (FX-820o).*

- FX-820o: Photograph of Dog Slough taken on August 31, 2016. This is a true and accurate copy of a photograph of the slough taken on August 31, 2016, during a river trip which I attended as part of my duties with the FWC. I was present when the photograph was taken, and it accurately represents conditions at the slough on that day.

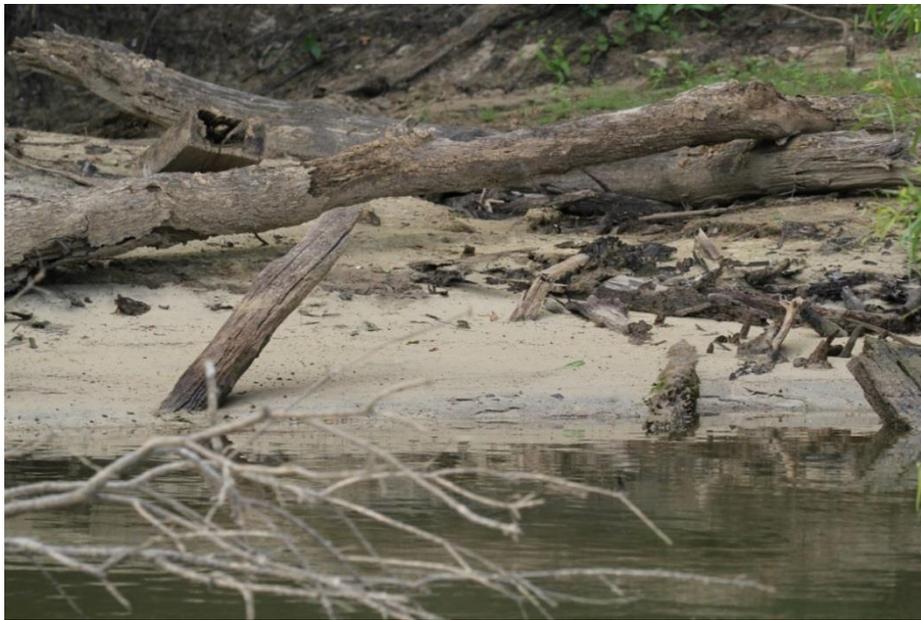
*Channel margin habitat at Hog Slough in the Lower Reach, near River Mile 40. This is a true and correct copy of a photo taken on August 2, 2016, during a river trip I attended. I was present when this photo was taken, and it accurately represents conditions at Hog Slough on that day when river flow was approximately 6,500 cfs as measured at the Chattahoochee gage on the Apalachicola River. (FX-812m).*

51. Channel margins along the main stem of the River are a preferred microhabitat for freshwater mussels. Mussels require stable substrate to propagate and find such substrates more often in the channel margins than in the main channel. Furthermore, the current along the channel margins is not as strong as in the main channel resulting in lower levels of shear stress. This is important because even though mussels can survive in parts of the deep channel of the River, they often cannot weather intense flood events that scour the bottom and alter habitat.

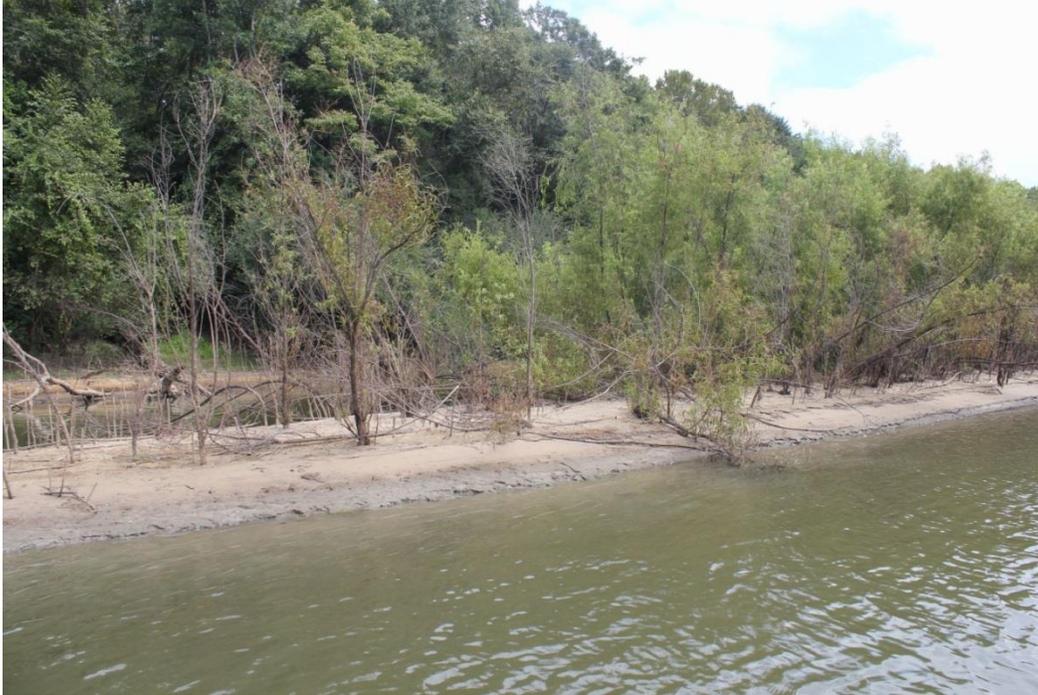
*Channel margin habitat federal listed mussel tagging site in the Lower Reach, near River Mile 46.9. This is a true and correct copy of a photo taken on August 31, 2016, during a river trip I attended. I was present when this photo was taken, and it accurately represents conditions at River Mile 46.8 on that day when river flow was approximately 5,500 cfs as measured at the Chattahoochee gage on the Apalachicola River. (FX-8231).*

- FX-823l: Photograph of federal mussel tagging site after Unnamed Slough taken on August 31, 2016. This is a true and accurate copy of a photograph of the mussel tagging site taken on August 31, 2016, during a river trip which I attended as part of my duties with the FWC. I was present when the photograph was taken, and it inaccurately represents conditions at the slough on that day.
